## **APR FSI Fuel Pump Installation Notes, Recommendations, and Precautions**

# Technical Service Bulletin

MIL on (DTC P2293 in ECM)

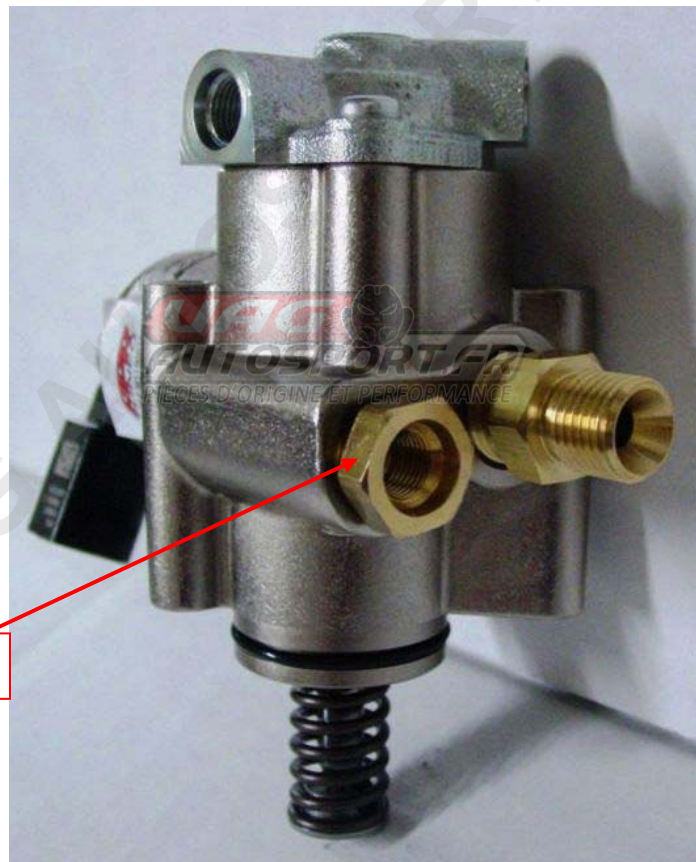
Banjo style fuel inlet fitting

FIG 1: FSI Fuel Pump shown with Banjo type fuel inlet fitting that is secured and sealed with a factory banjo fitting (already on vehicle fuel line) and a banjo-style bolt.

5.1. There are two types of fuel inlet fittings that VW/Audi uses for the high-pressure FSI fuel pump (see figures 1 and 2):

- 5.2. If you are purchasing a new (not a rebuilt) APR FSI Fuel pump, you will receive the pump with the “Bamboo” type barbed fitting. You will need to check the type of fitting that your vehicle was originally equipped with to determine whether or not your original fuel line is compatible with the Bamboo fitting. If your vehicle is directly compatible with the Bamboo fitting, you can install your APR FSI fuel pump without the need to remove and/or reinstall any of the fittings on the pump

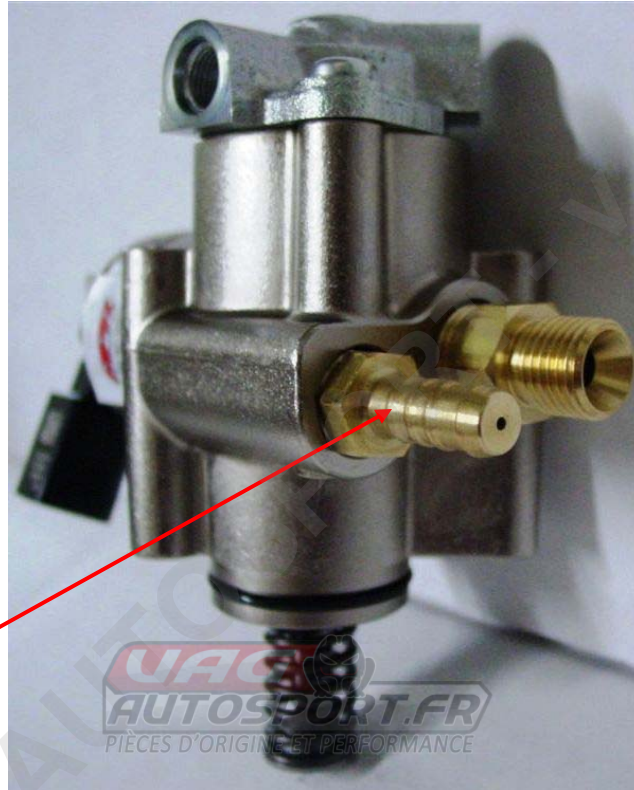
“Bamboo” style fuel inlet fitting

FIG 2: FSI Fuel Pump shown with “Bamboo” type fitting where a hose is pushed-on to the barbed fitting and secured with a hose clamp.

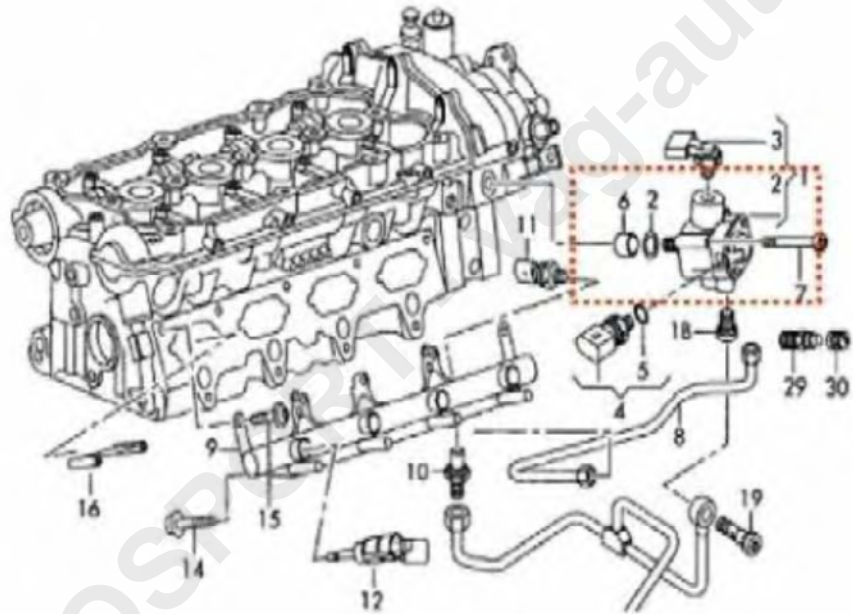
1. Remove the high pressure fuel pump and visually inspect:
  - The base surface of the cam follower (Figure 1, Point 6) in contact with the camshaft lobe.
  - The tip of the high pressure fuel pump plunger.
  - The high pressure fuel pump camshaft lobe.

Figure 1. The high pressure fuel pump.

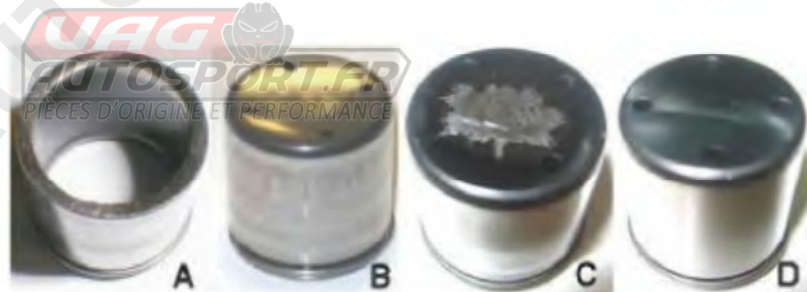
2. If the base of the cam follower looks like Figure 2, C or Figure 2, D, no excessive wear is present. The cam follower and camshaft should not be replaced.

Figure 2. Cam followers in various stages of wear: holed base (A), excessive wear (B), normal wear (C), and new part (D).

3. If the cam follower base surface is excessively worn so that its surface is concave (Figure 2, B) or altogether missing (Figure 2, A), or if the high pressure fuel pump camshaft lobe shows excessive wear (Figure 3), replace the intake camshaft and the cam follower.

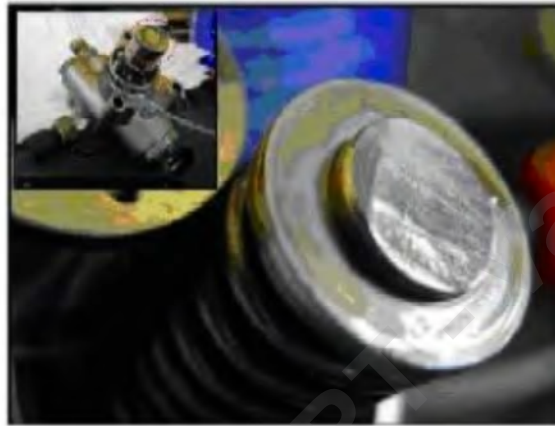
Figure 4. Excessive wear marks on the tip of the high pressure fuel pump plunger.

4. The high pressure fuel pump must be replaced only if the tip of the plunger shows excessive wear (Figure 4). This condition is only possible if the cam follower base is holed and the plunger tip has come in direct contact with the camshaft lobe.
5. If no excessive wear can be found in the high pressure fuel pump cam follower or intake camshaft lobe, or if the damage is found in camshafts with part number 06F 109 101 B, please create a Technical Assistance Contact Ticket under the Concern Type Engine and Engine Electronics in ElsaWeb. Attach the complete diagnostic log to the contact, and call the Audi Technical Assistance Center (Audi Helpline) for further assistance.
